HURRICANE DORIAN

DAMAGE ASSESSMENT OF THE BAHAMAS

GeoHIVE

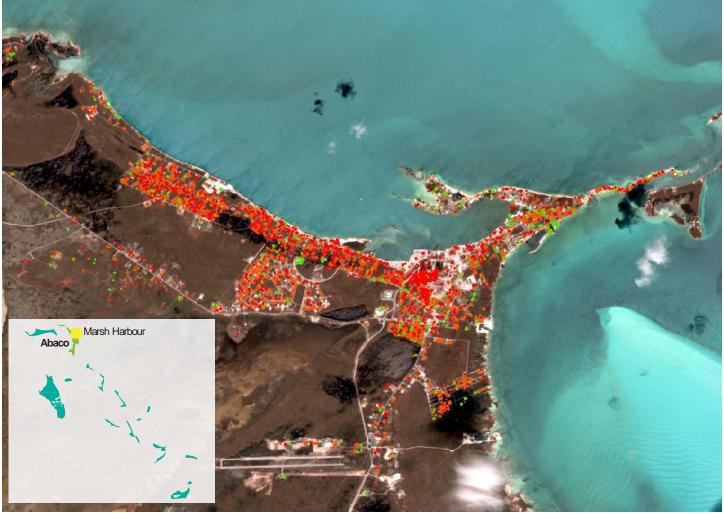
The Bahamas' Abaco Islands, and the Marsh Harbour area (estimated population 5,728 as of 2018) experienced the full effects of this storm when it reached the islands on September 1, 2019. A GeoHIVE damage assessment campaign on Marsh Harbour revealed, of the 4,076 buildings evaluated, only 16% had no visible damage while 45% were visibly damaged and 39% were visibly destroyed.

Buildings Assessed: 4,076

- Visibly Damaged: 1,848
- No Damage Visible: 662

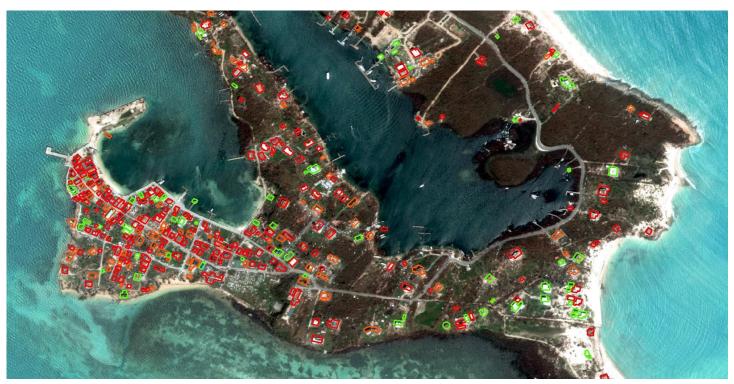
SAMPLE IMAGES - 3 LEVELS OF DAMAGE

Visibly Destroyed

Visibly Damaged

No Damage Visible
